Annual Compliance and Audit Report

EPBC 2022/09324

Lot 12736 (#210) Wesco Road, Nowergup

Surefire Environmental Pty LtdAnnual Compliance Report –
Period 09 September 2024 – 08 September 2025

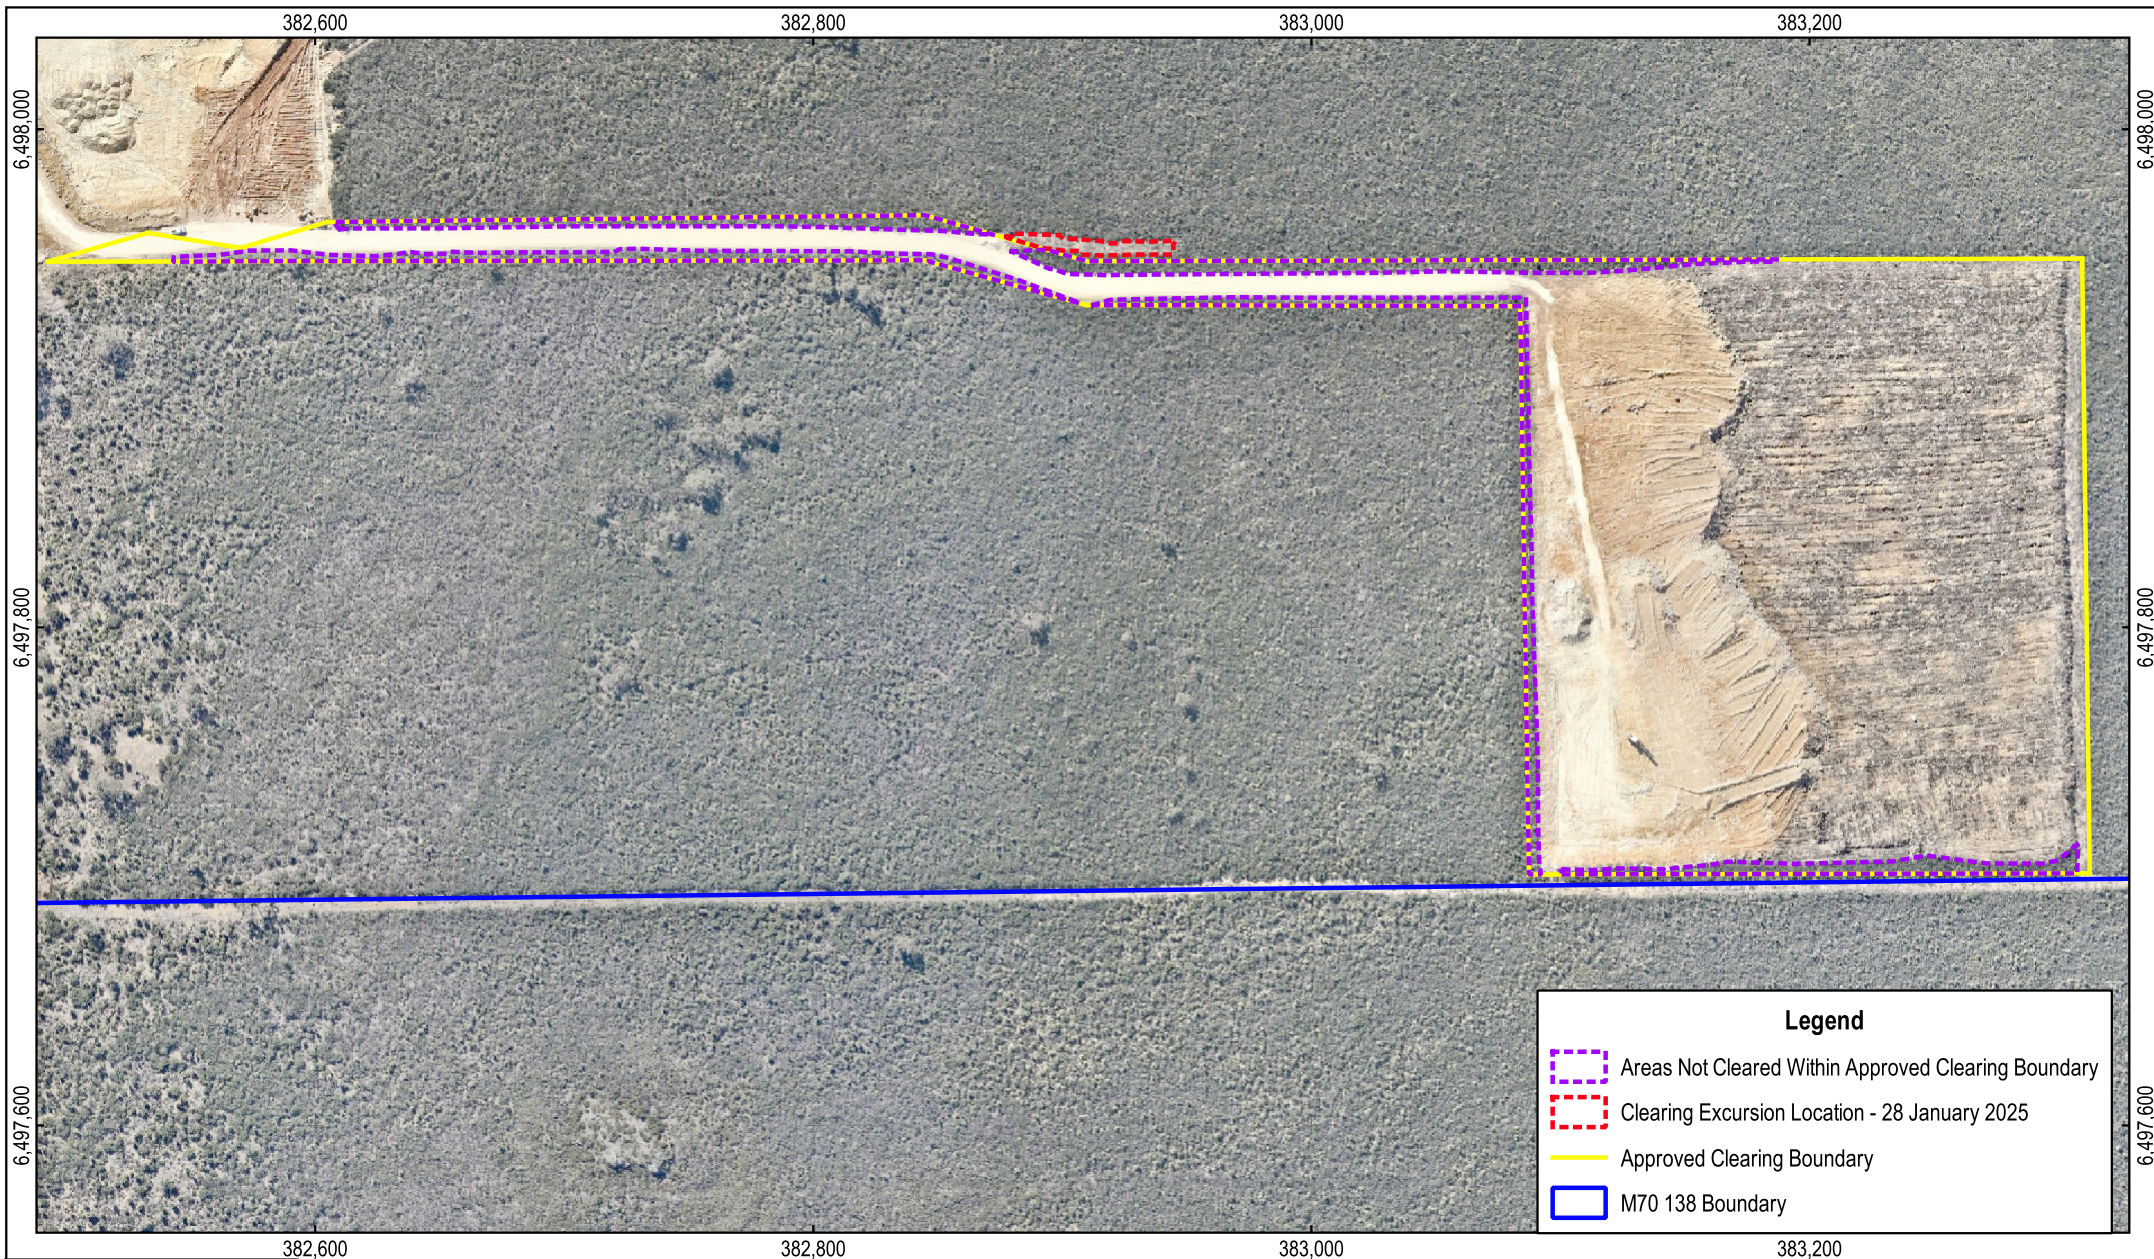
The project location is an active mine where limestone extraction is currently being undertaken, with the new pit located within the area cleared under the terms of the EPBC 2022/09324 approval.

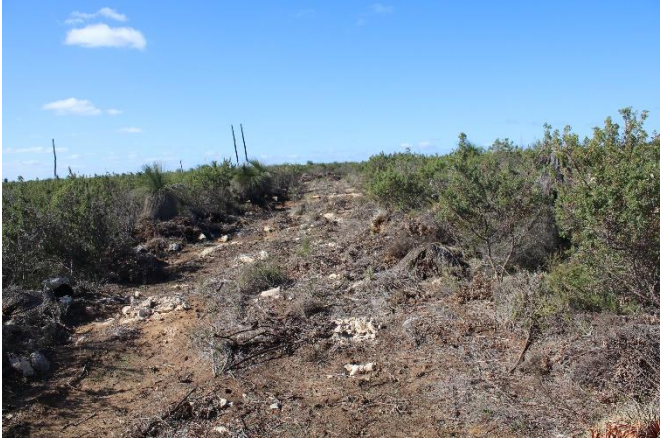
ID	Condition Requirement	Compliance Supporting Information	Compliance
	d) if any incident occurred, accurate and complete details of each incident.	<ul style="list-style-type: none"> During clearing activities on 28 January 2025, the mis-sighting of the flagging tape marking out the clearing boundary meant the bulldozer was directed straight ahead rather than taking a bend on the access way, resulting in the inadvertent clearing of 329.8 m² outside the nominated boundary (single pass of the bulldozer blade)

<ul style="list-style-type: none"> The bulldozer reversed out of the area and continued within the nominated clearing boundary, with no further incidents associated with the clearing area occurring The incident was reported to DCCEEW on 30 January 2025 via email An investigation occurred into causes and contributing factors, with suggestions for any future clearing, as once the boundary of the site was cleared, the chances of inadvertent 	C

ID	Condition Requirement	Compliance Supporting Information	Compliance
	c) the method and timing of any corrective measures that the approval holder proposes to undertake to address the incident.	<ul style="list-style-type: none"> In the first instance, natural regeneration of the cleared area will be allowed to progress If required, additional restoration methods will be applied to restore the site to a similar condition prior to the clearing 	C

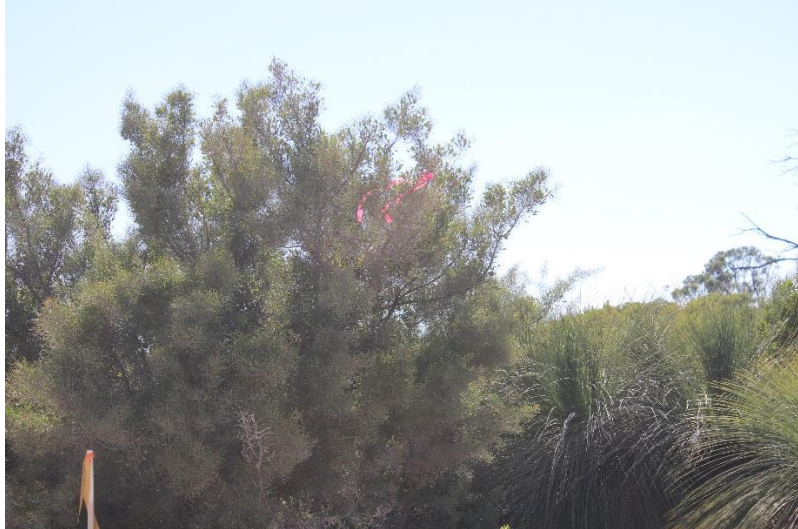
Clearing beyond approved boundary:		
Delineating clearing area prior to clearing commencing using flagging tape or other suitable means	<p>Clearing boundary marked with flagging tape prior to clearing commencing</p>

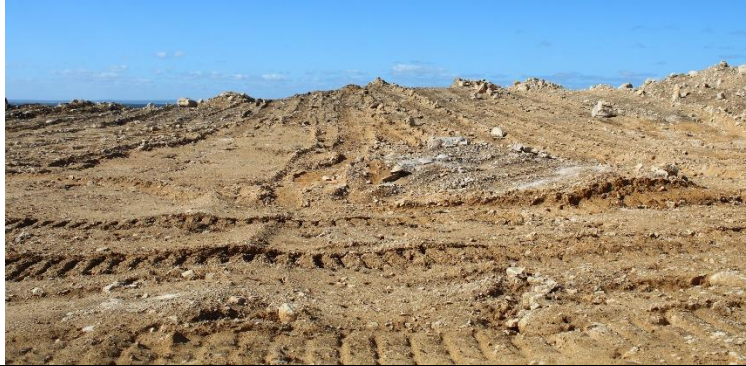
CEMP Commitments	Compliance Supporting Information	Compliance
Topsoil stockpiles will be no greater than 4 m in height	Stockpiles within site less than 4 m

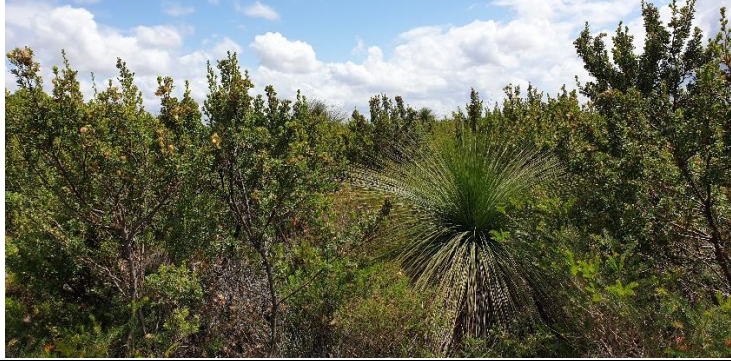
If appropriate, unwanted or unnecessary access to vegetated areas will be discouraged through track signage and education	Not applicable – there is only one access option to the Site	N/A
Weed affected topsoils may need to be taken offsite or buried by 500 mm soil/overburden	Not applicable – the weed presence within the Site was limited

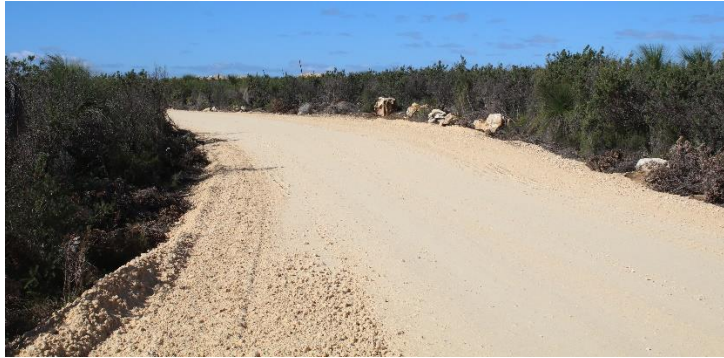
Entry to and exit from the PAA will be limited to the nominated access track only	<p>Access is available from the single access track created during the clearing process</p>

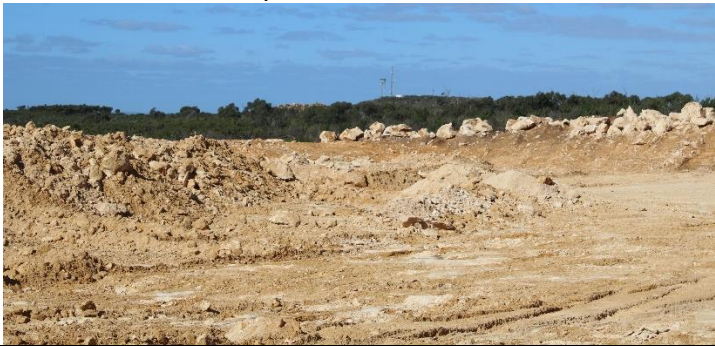
CEMP Commitments	Compliance Supporting Information	Compliance
Signage regarding unauthorised entry and 'clean on entry' requirements will be placed at the overall site entry	<ul style="list-style-type: none"> Unauthorised entry is indicated at the Meteor Stone entry from Wesco Road The 'clean on entry' sign has since been damaged, removed, and not replaced as clearing is complete and vehicle movements are confined to those associated with extraction activities, with no deviation from the specified access route 	C
Vegetation and topsoil will be removed and stockpiled in accordance with the provision of the Mine Closure Plan (Landform Research, 2020), and the subsequent movement of vehicles and machinery will be limited to the areas that are cleared of vegetation	<p>Stockpiles are currently within the cleared area, away from current extraction operations</p>
